RE: July Monthly Report
1.5 Mile Reach Removal Action
GE-Pittsfield/Housatonic River Site

Enclosed please find the July 2006 Monthly Report for the 1.5 Mile Reach Removal Action. In accordance with the Consent Decree for the GE-Pittsfield/Housatonic River Site, the United States Environmental Protection Agency (EPA) is performing the 1.5 Mile Reach Removal Action, with General Electric funding a portion of the project through a cost sharing formula.

Figure 1- 1.5 Mile Removal Action Site Map (2 maps)

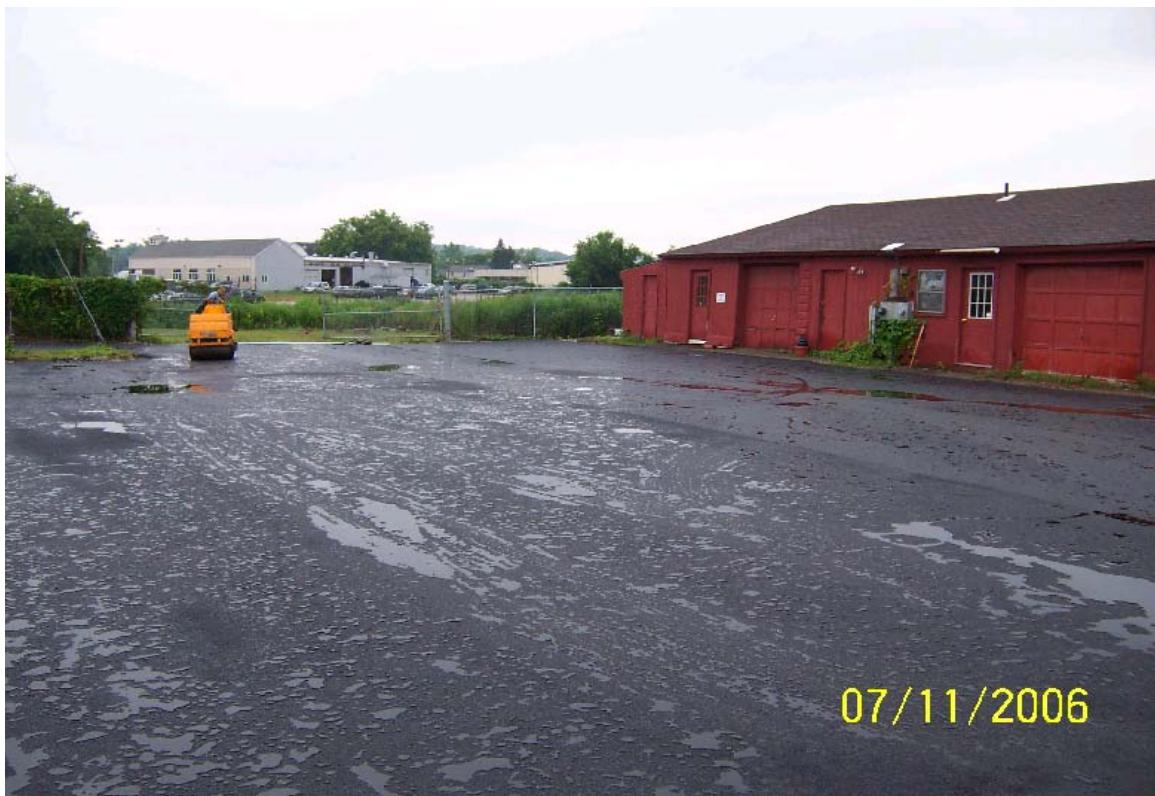
Photograph 1 – Restoration Activities on Parcel I8-24-5

Also, by the end of June, final restoration activities on Parcel I8-24-5 were initiated. During the month of July, the final restoration activities on Parcel I8-24-5 were completed. First, the final grading was complete. Next, the paving was done. Pea stone was installed around the newly paved parking lot areas. Finally, permanent chain link fencing was installed on the property.

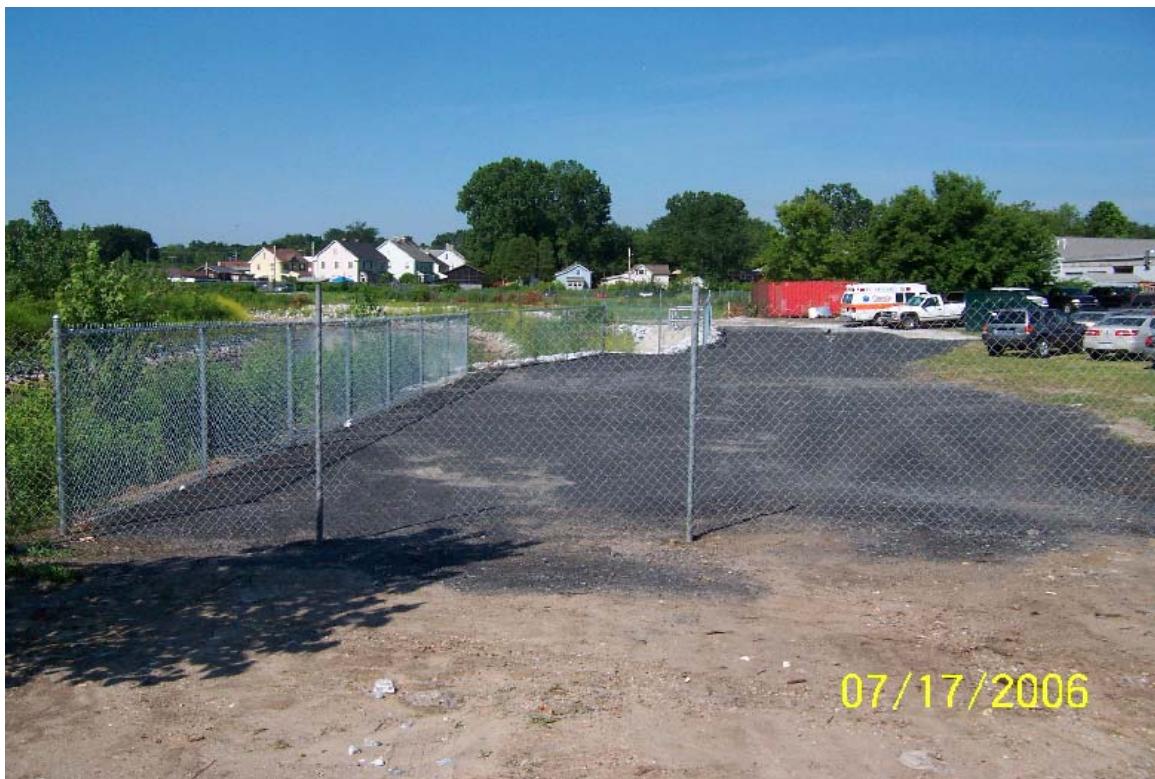
Photograph 2 – Overview of Restored Parcel I9-4-25

By the end of June, activities associated with the restoration of Parcels I9-4-25 and I9-4-203 were underway. During the month of July the restoration of Parcels I9-4-25 and I9-4-203 were completed. First, placing of the black stone driveway mix was completed then the installation of permanent chain link fencing was completed.

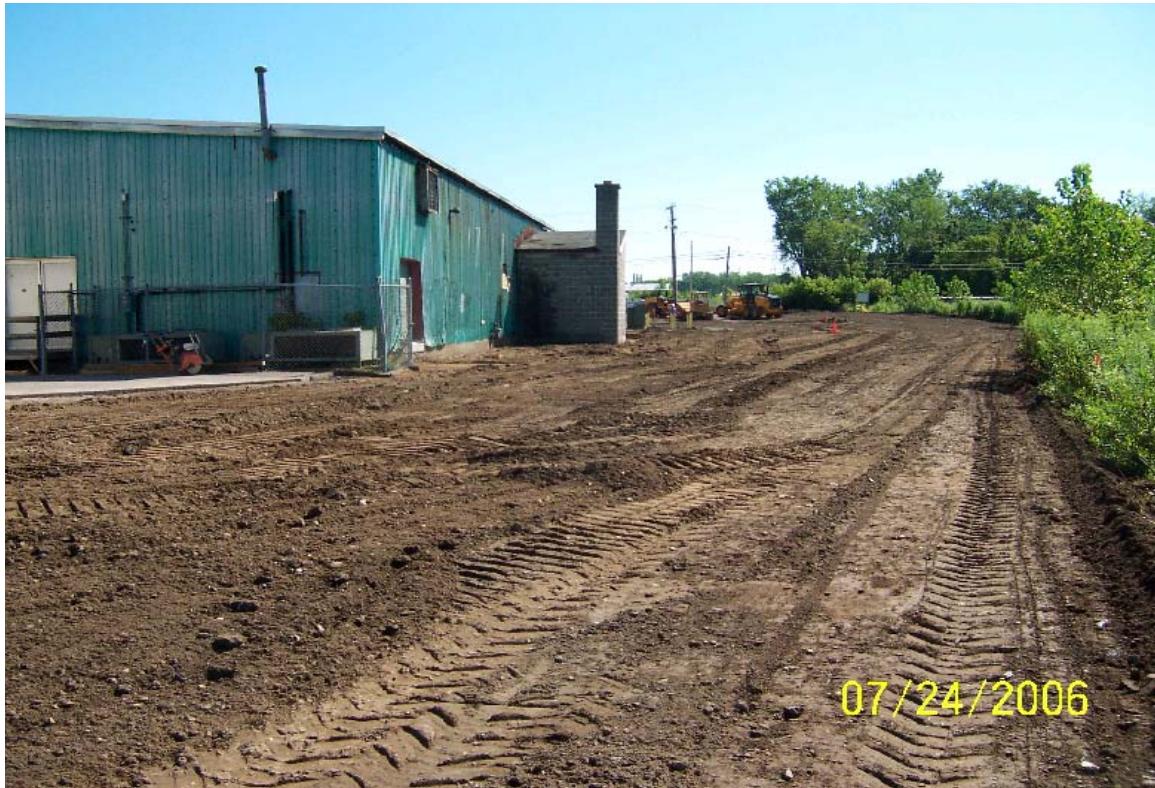
Photograph 3 – Restoration Activities on Parcel I9-4-201

Final restoration activities on Parcel I9-4-201 were initiated. First, the removal of all debris and soil was removed from the areas that were slated for asphalt re-claiming and paving. All removed debris material was transported to Area 64. The removal of the temporary fence was completed. Next, the existing asphalt was removed and re-claimed for use as sub-grade material, the sub-grade was fine graded and excess material was removed and transported to Area 64. Then, the parking lot was paved. The installation of the topsoil around the newly installed pavement and the installation of permanent fencing are scheduled for August 2006.

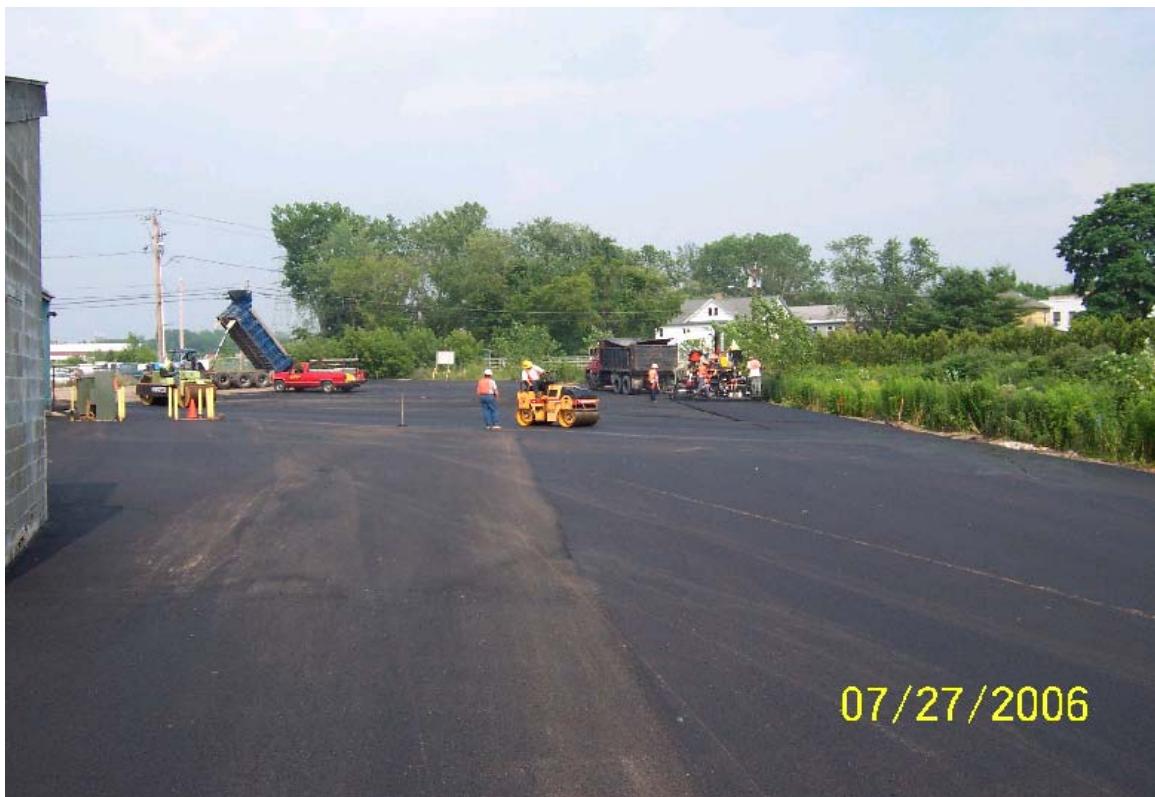
Photograph 4 – Restoration Activities on Parcel I9-4-201

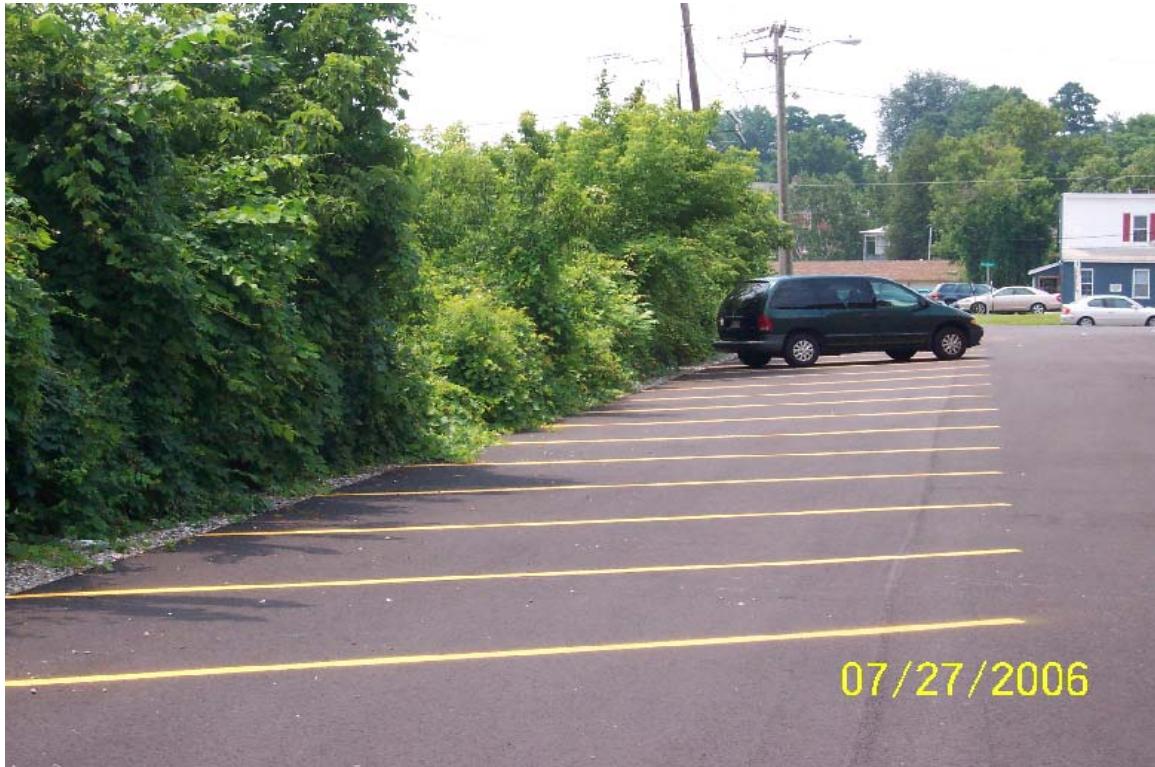
Photograph 5 – Overview of Restored Parcel I8-24-1

Other restoration activities during the month of July included the striping of the parking lot on Parcel I8-24-1. The installation of concrete curbing on Parcel I7-2-1 was completed. Topsoil was then added and the area between the concrete curb and the sidewalk was re-graded and seeded.

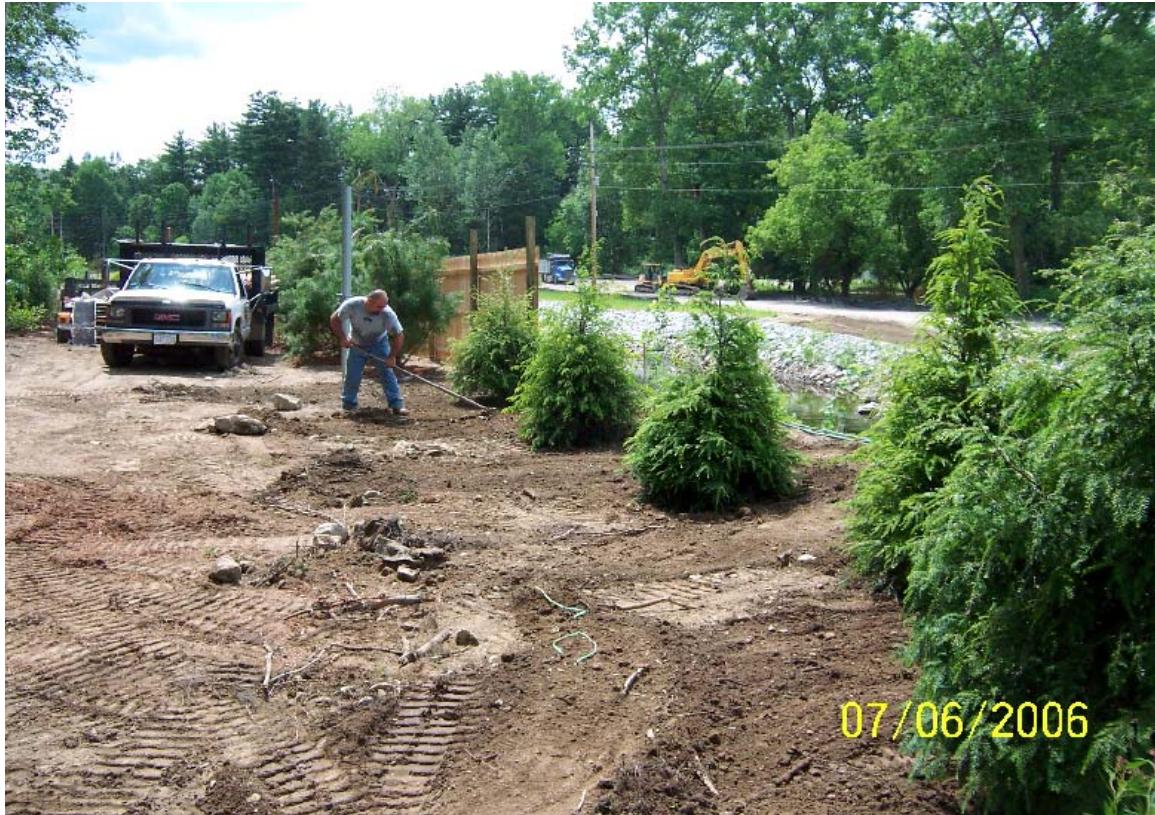
Photograph 6 – Upland Planting Activities on Parcels I6-1-66, I6-1-67 and I6-1-68

Also, during the month of July, the 2006 spring/summer planting activities continued. The planting of the hemlocks and decorative shrubs on Parcels I6-1-68 and I6-1-69 was completed. Also, the upland planting and the riverbank planting on Parcels I6-1-66 and I6-1-67 was completed. All disturbed and newly planted areas were then hand raked and hydro-seeded.

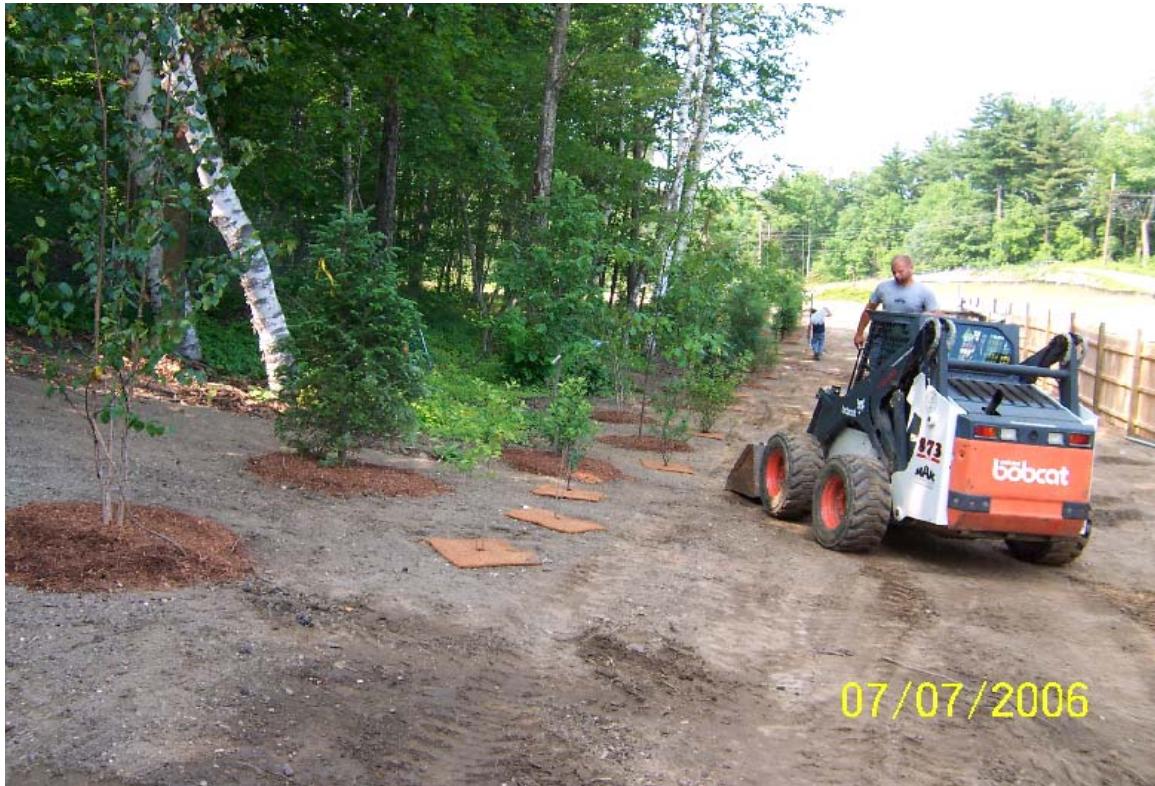
07/07/2006

Photograph 7 – Upland Planting Activities on Parcels I6-1-66, I6-1-67 and I6-1-68

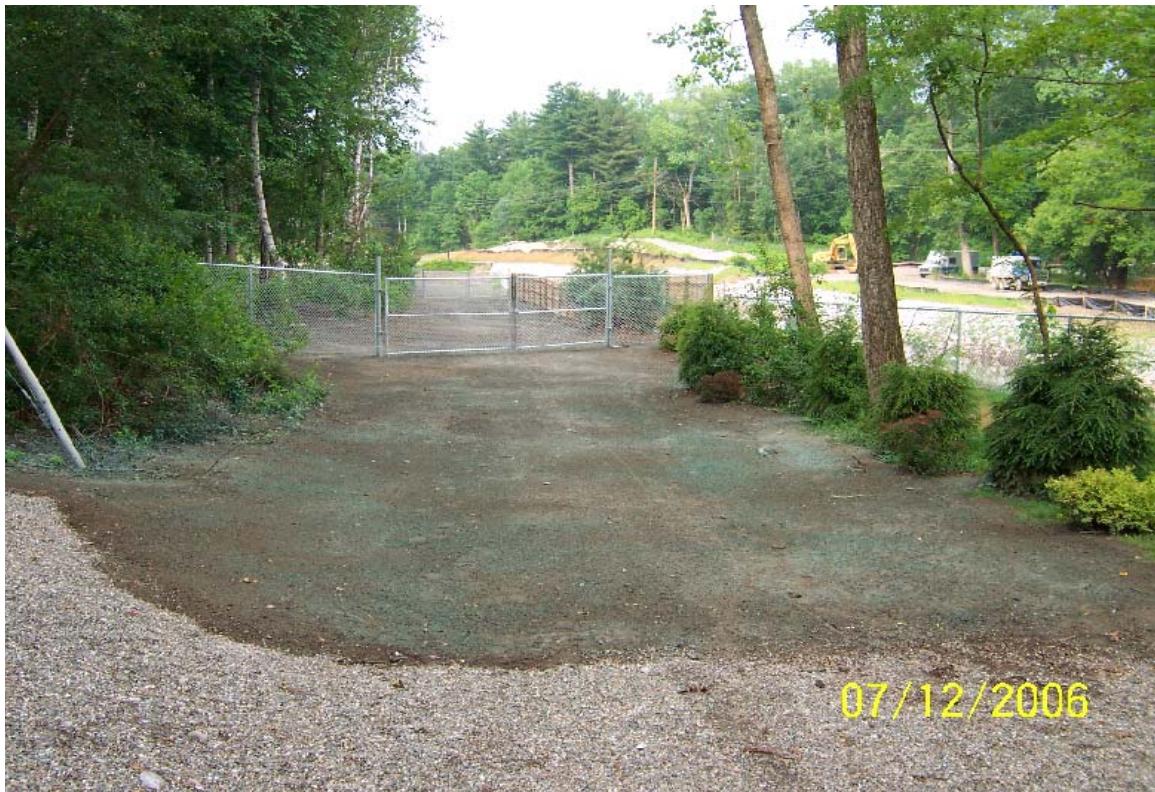
07/12/2006

Photograph 8 - Overview of Restored Parcels I6-1-66, I6-1-67 and I6-1-68

Final restoration activities on Parcels I6-1-66, I6-1-67 and I6-1-68 continued. The installation of a 6-foot high wood stockade fence along the top of the riverbank on Parcels I6-1-67 was completed. The installation of a 6-foot high chain link fence along the property boundary line between parcels I6-1-66 and I6-1-67 was completed. Also, the installation of the two Sewer Right Away (ROW) gates located at the property boundary line between Parcels I6-1-67 and I6-1-68 and on the property boundary line between Parcels I6-1-66 and I6-1-67 was completed. Per request of the property owner the site security fencing on Parcels I6-1-67 will not be removed until October 2006.

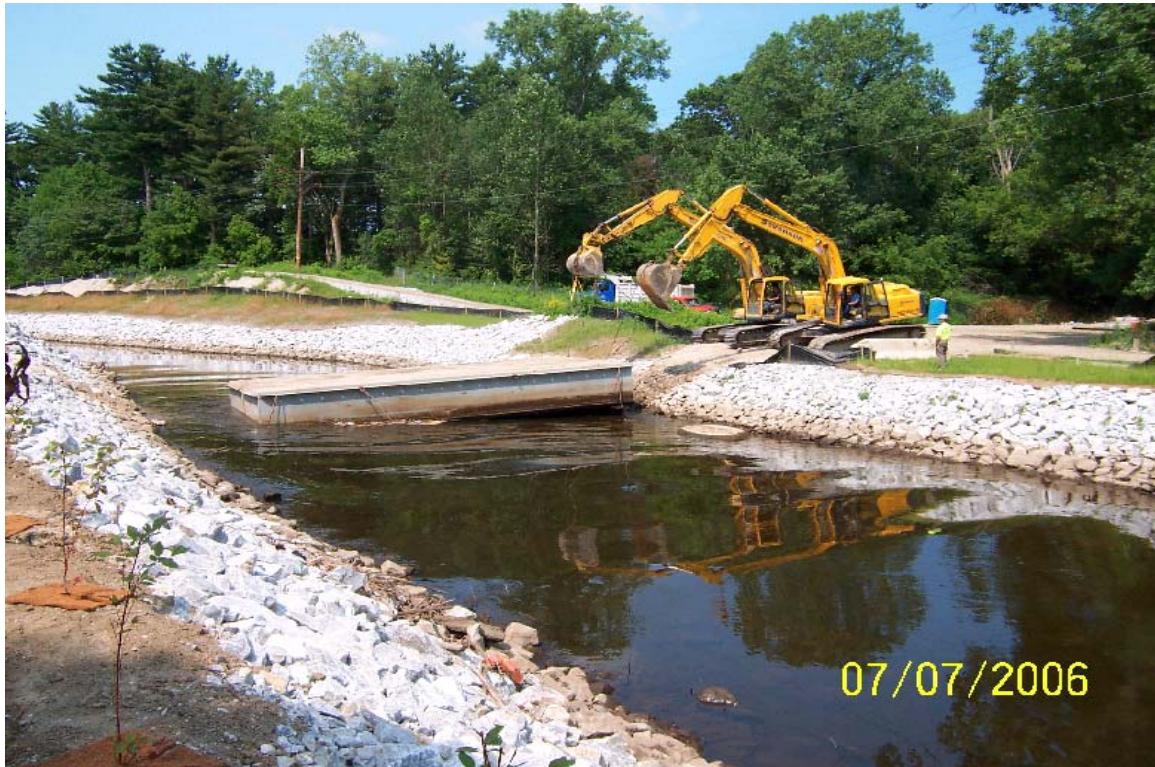
Photograph 9 – Removal of the River Crossing Barge in Phase 3C

GE contractors, as part of their GE Floodplain Remediation activities, removed the floating river barge crossing in Phase 3C. The barge sections were then decontaminated and demobilized offsite.

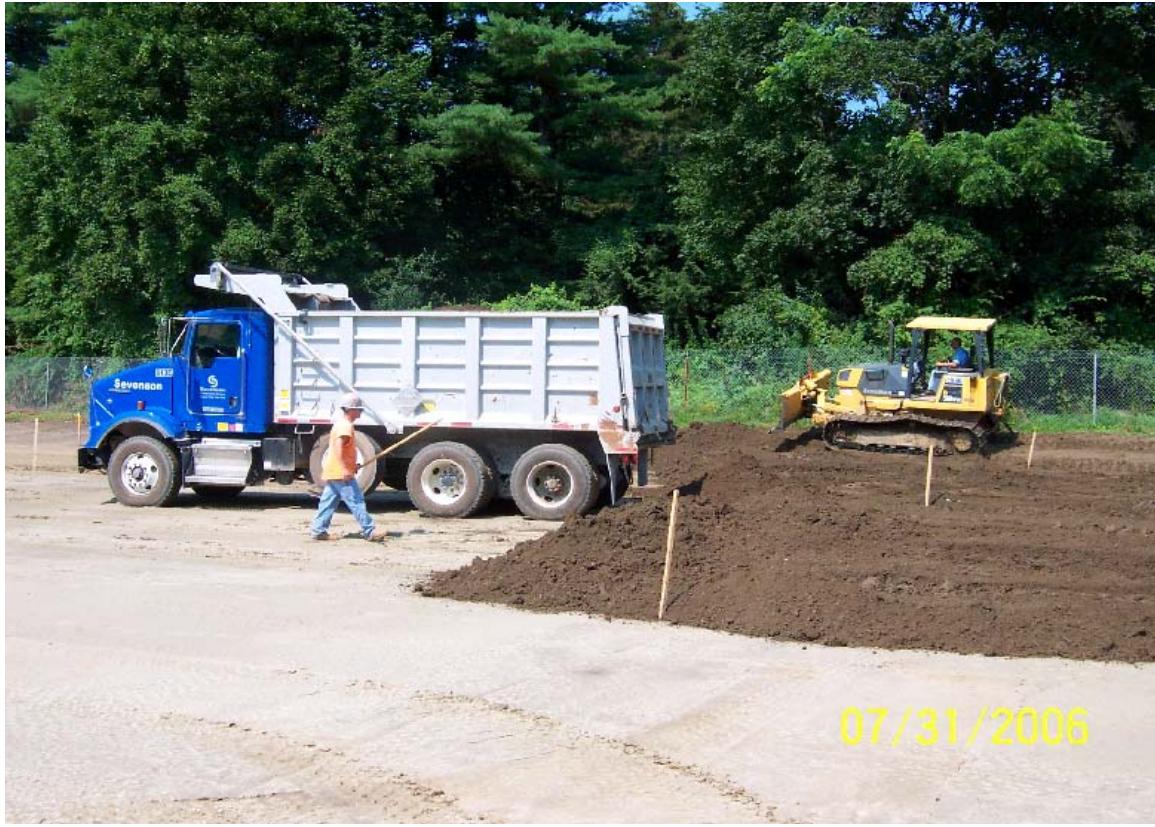
Photograph 10 – Installation of the Topsoil on the Soccer Field in Fred Garner Park

The final restoration activities at the Fred Garner Park were initiated. The tree clearing and grubbing activities were completed. Also, the removal of the wood bollards from the perimeter of the park was completed. The removal of the 2-inch layer of sod in the areas within the soccer field was completed. The removed sod material was transported to Area 64 and was slated for offsite disposal. Then, the survey contractor staked out the location and the grades for the soccer field and the grading activities of the soccer field were completed. The high areas at the northwest corner of the field were cut and the cut material was used to fill in the lower area on the east side of the field. Next, the installation and grading of the sand base over the soccer field was completed. Finally, the installation and grading of the 6-inch layer of topsoil over the soccer field was initiated.

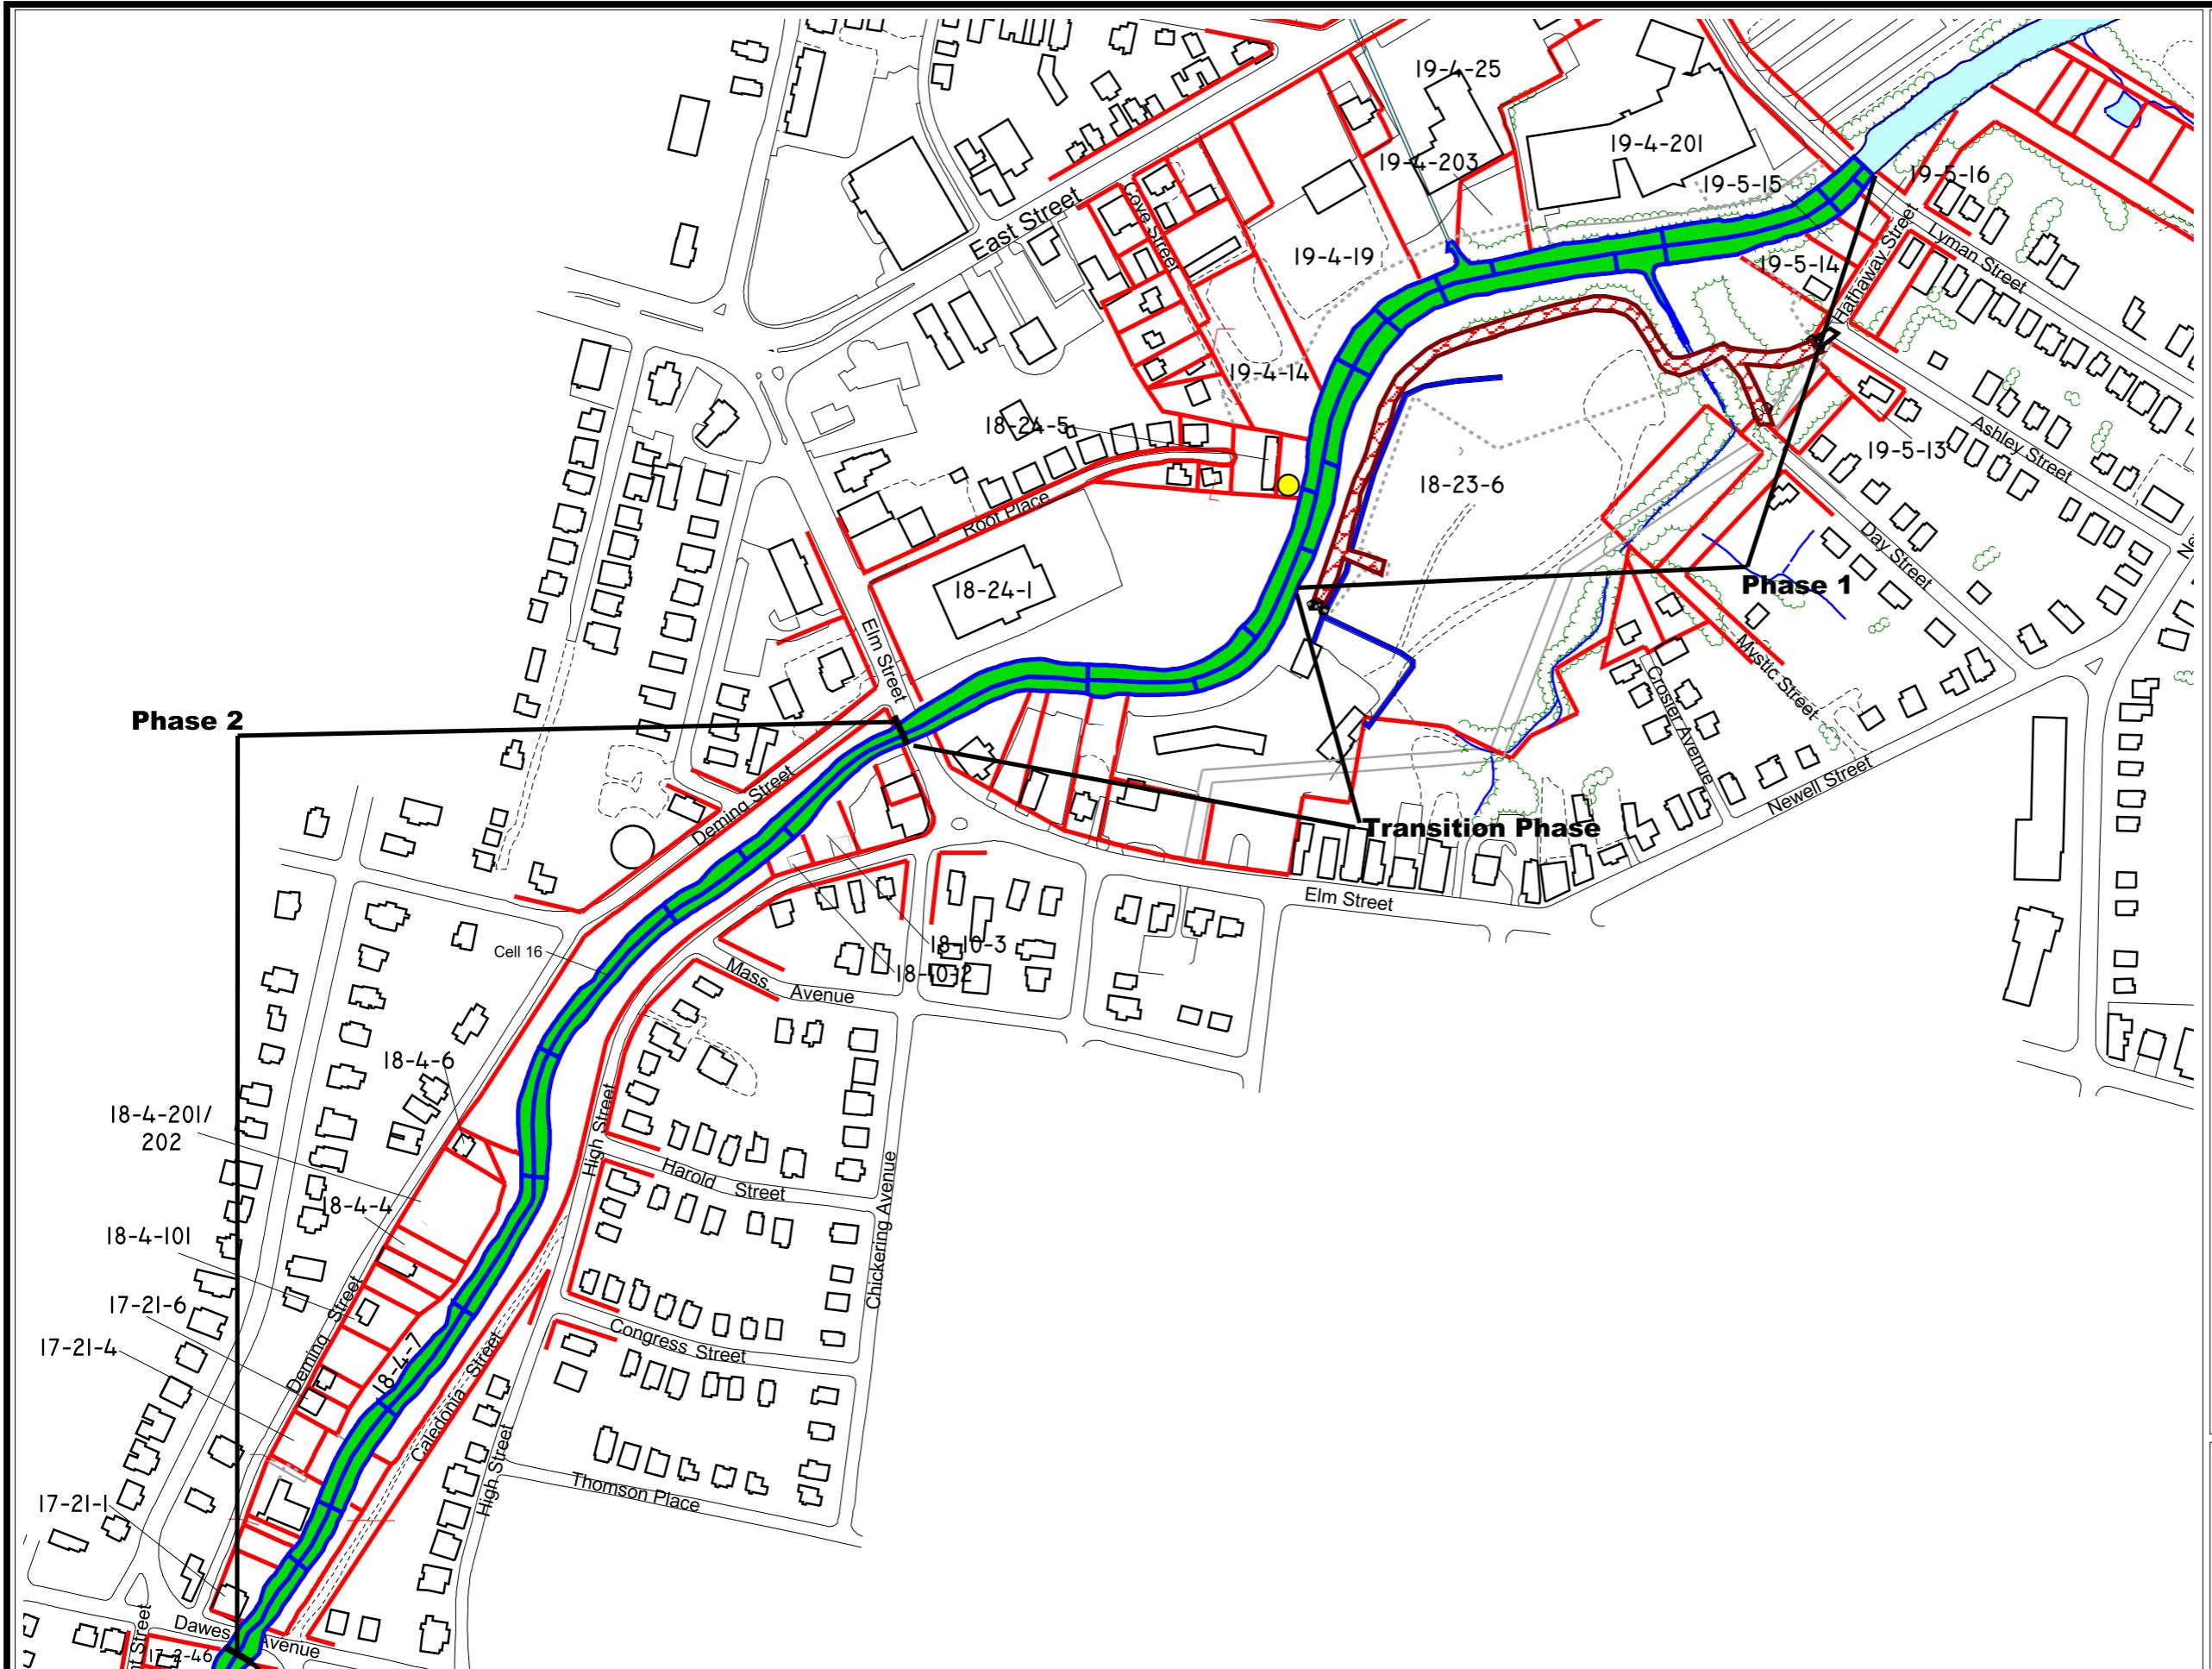
Figure 1
1.5 Mile Removal Action
Site Map (Map 1 of 2)
July 2006 Monthly Report

Figure 1 (2 maps) includes the layout of all excavation cells, vibration monitoring locations, access road locations, excavation load-out locations, staging area locations, fence line location, the water treatment system pad locations and the floating river barge crossing.
